Independent Observer summary report on *MV Ocean Shearer*

Cattle exported to Indonesia in December 2019

Report 208, April 2020

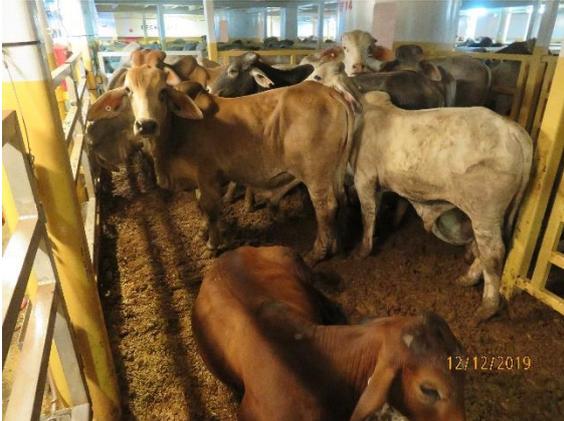
Day 2 – Cattle in pen. No issues identified.

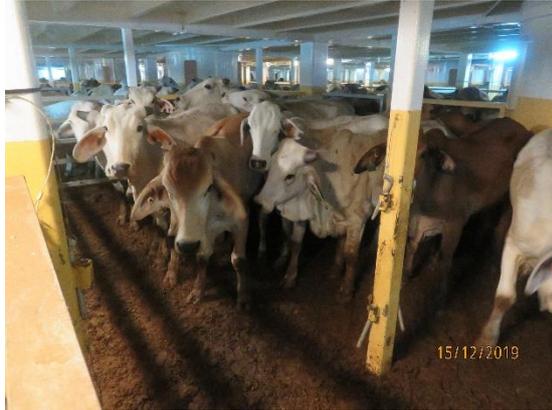
Day 4 - Cattle in pen. No issues identified.

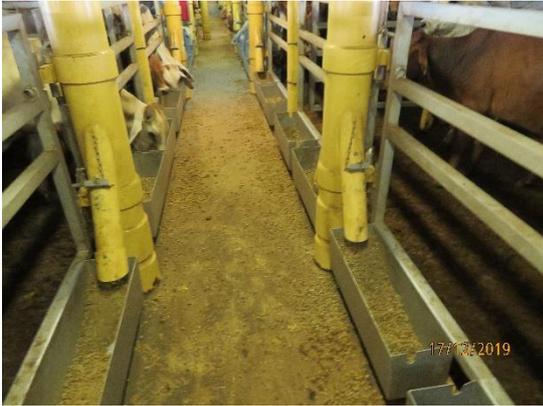
Day 6 – Laneway after feeding. No issues identified.

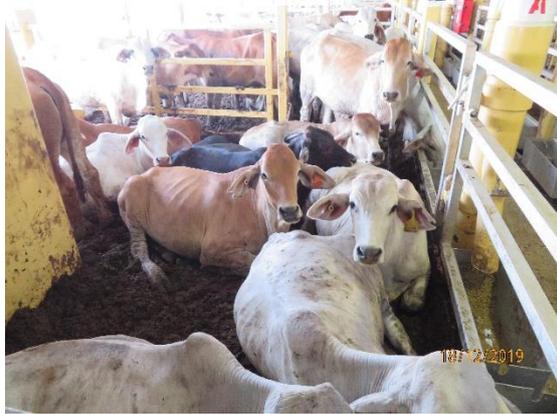
Day 9 - Cattle in pen. No issues identified.

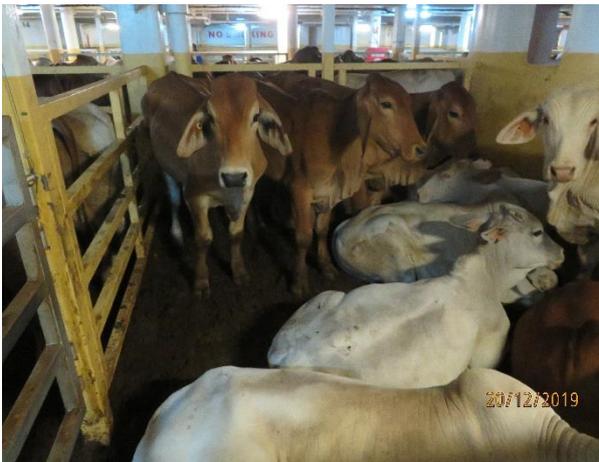
Day 11 – Cattle in pen during discharge. No issues identified.

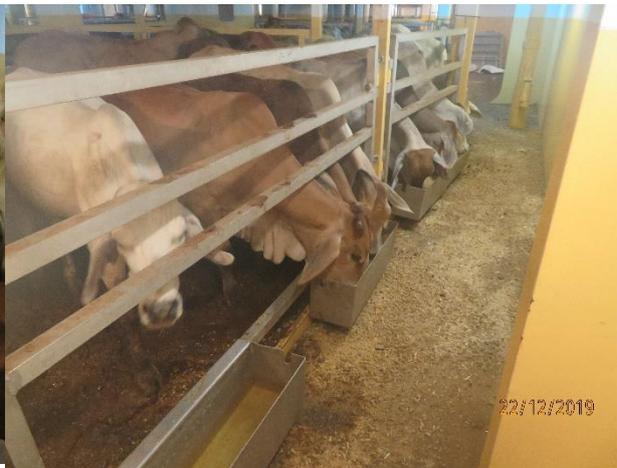
Day 12 - Cattle in pen during discharge. No issues identified.
