Independent Observer summary report on *MV Shorthorn Express*

Cattle exported to China in December 2018

Report 55, February 2020

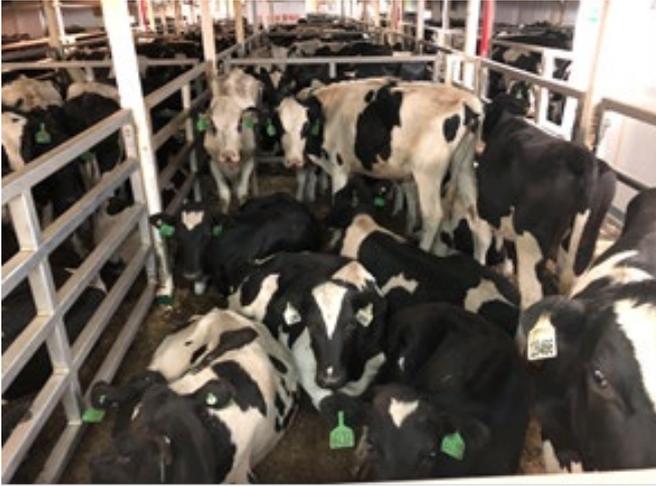
Day 1 Cattle in pen – no issues identified

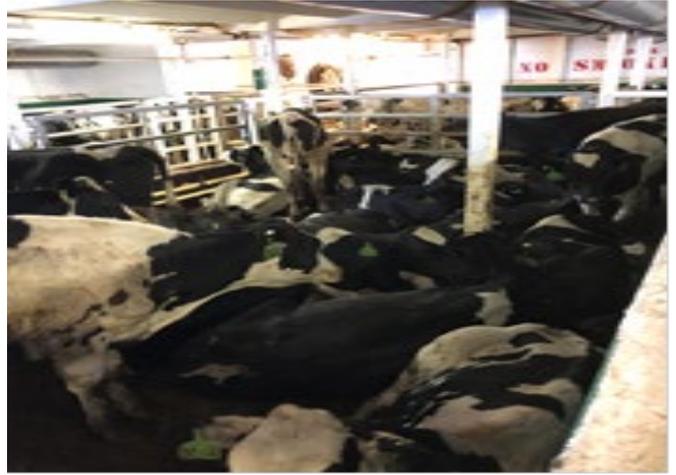
Day 4 Cattle in pen – no issues identified

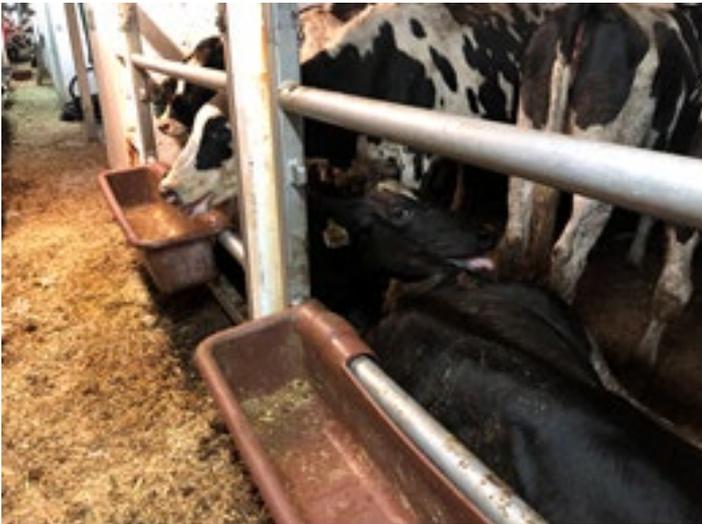
Days 7-15 recorded wet bulb temperatures ranging from 29-34°C as the vessel crossed the equatorial region. Varying degrees of heat stress became apparent to the observer over these days. Most animals exhibited behaviours consistent with a heat stress score of 0-2. These adverse environmental conditions, particularly noted by the observer in pens close to the engine room and ventilation shafts, coupled with the lack of continuous water supply, contributed to the increased susceptibility of up to 5% animals who were observed with a heat stress score of 4 over days 7-13. A reported <10% of cattle were more affected on days 7-9, and were ascribed heat stress scores from 3.5 to 4 by the observer. By day 15, the average wet bulb temperature reduced to 25°C, with no cattle observed affected by heat.

Day 6 Cattle showing heat stress

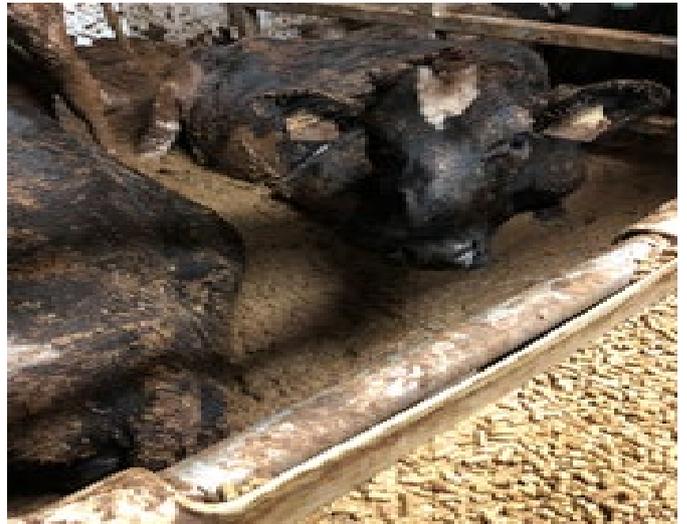
The observer commented that unsatisfactory pen and deck conditions were experienced during the voyage. These conditions were mainly due to inadequate corrective maintenance by crew, leaking water pipes and fire hydrants, malfunctioning nose bowls, build-up of the thickness of the pad, spilled feed in the aisles, high temperatures and humidity and blocked drains.

Day 7 Cattle in poor pen conditions

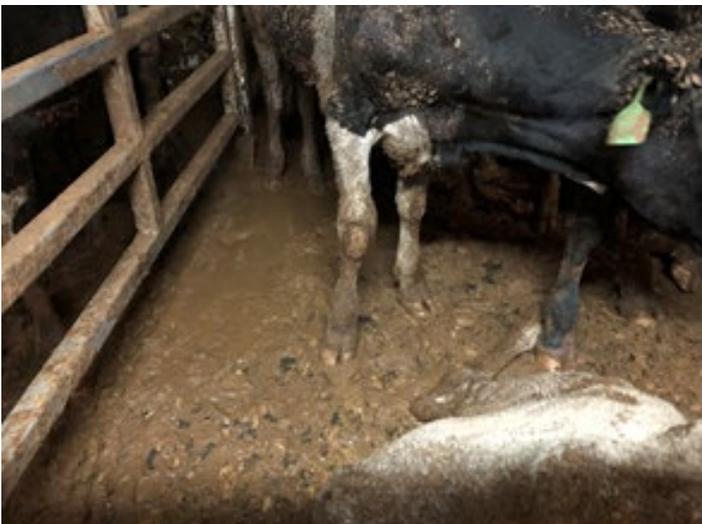
Washing of decks commenced on Day 7, with Deck 1 washed five times throughout the voyage. The remaining four decks were washed four times each on days 8/9, 12, 15 and 18. Wash down was observed to improve pen, environmental and animal welfare conditions.

Day 13 Cattle in pen after deckwash

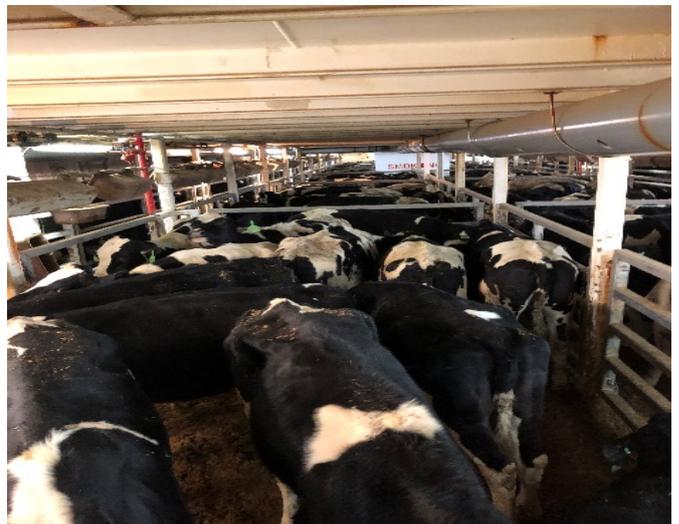
Day 18 Cattle in pen – no issues identified
