Independent Observer summary report on *GL Kai Hou*

Cattle exported to Vietnam in March 2019

Report 97, October 2019

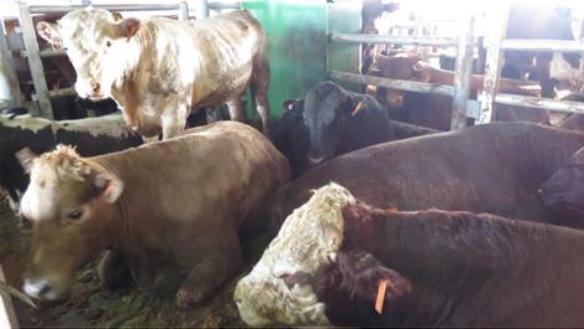
Day 2 cattle in pen – no issues identified

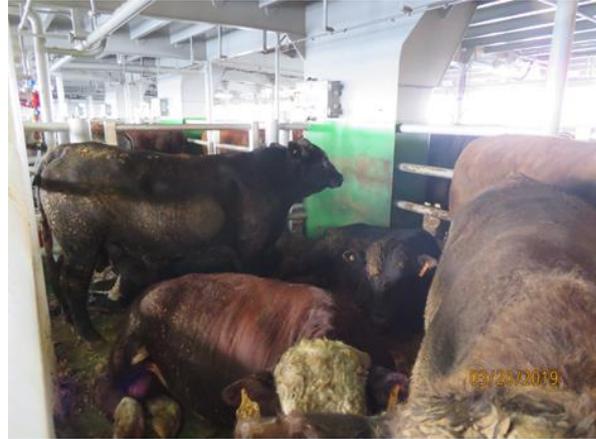
Day 5 cattle in pen – no issues identified

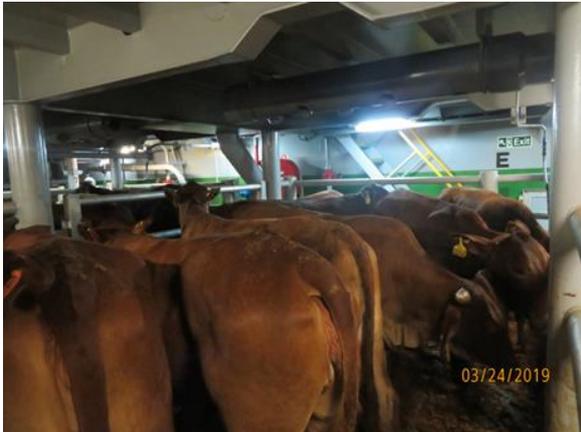
Day 8 Cattle in pen – no issues identified

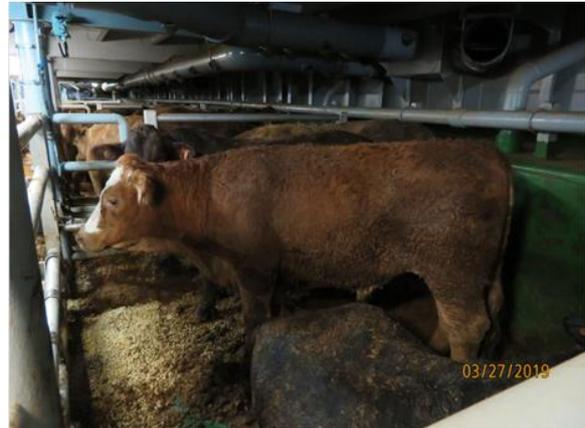
Day 11 Cattle in pen – no issues identified

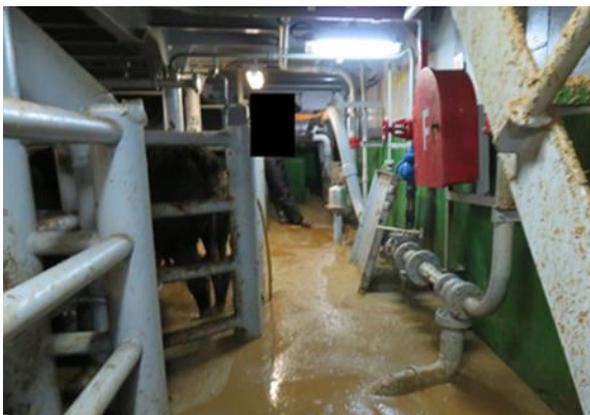
When washing pens, all decks drained to Deck E. This caused a large build-up of water on Deck E during the washing process with cattle standing in water for a number of hours. The vessels extraction pumps did not seem to be able to keep up with the volume of water and waste produced by the deck washing process. The observer has clarified that they were unable to determine whether the incidence of lameness was greater where water inundation occurred as a result of poor drainage. Remedial action was to be undertaken by the vessel to correct this issue and will be monitored by the department when an observer is on-board.

Day 14 Lower Deck E – build-up of drainage

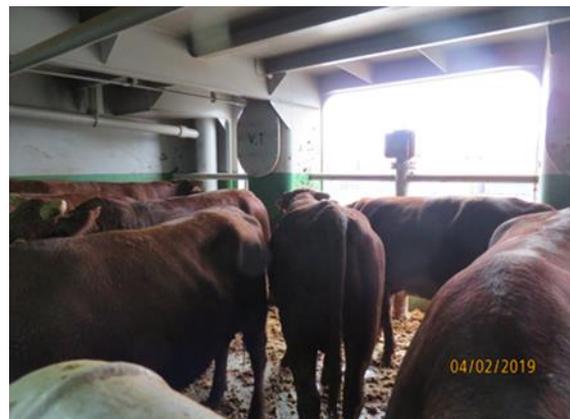
Day 17 Cattle in Pen – no issues
