Independent Observer summary report on MV *Dareen*

Cattle exported to Vietnam in December 2018

Report 51, October 2019

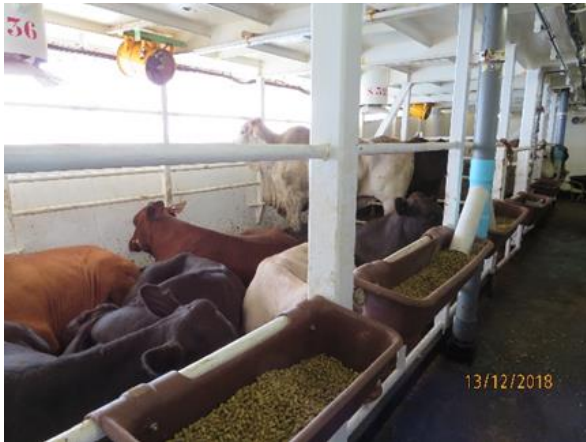
Day 2 Cattle in pen — no issues identified

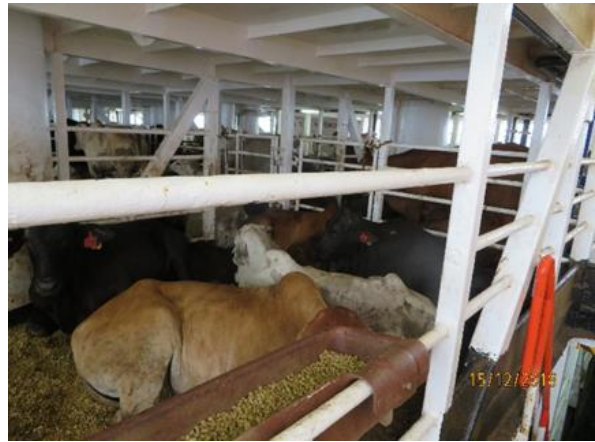
Day 4 Cattle in pen — no issues identified

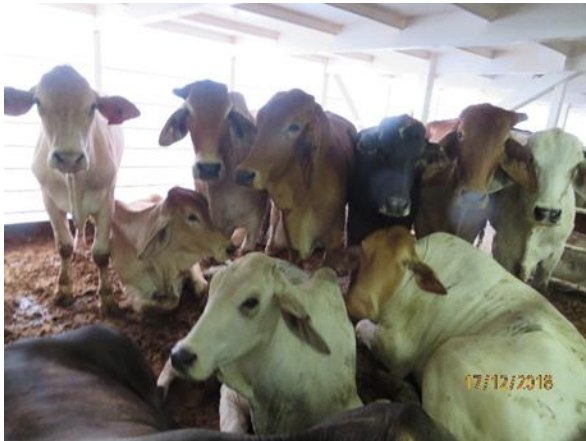
Day 6 Cattle in pen — no issues identified

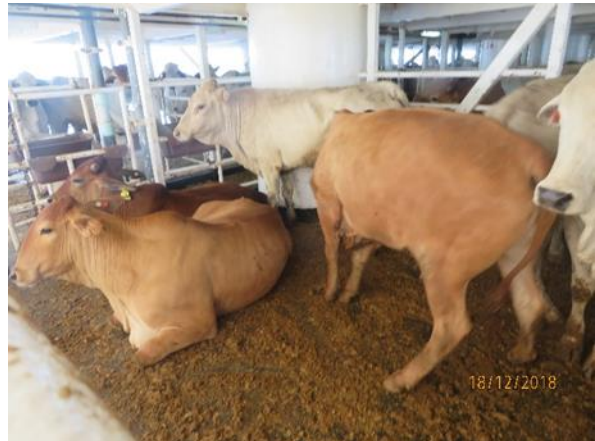
Day 7 Cattle in pen — no issues identified

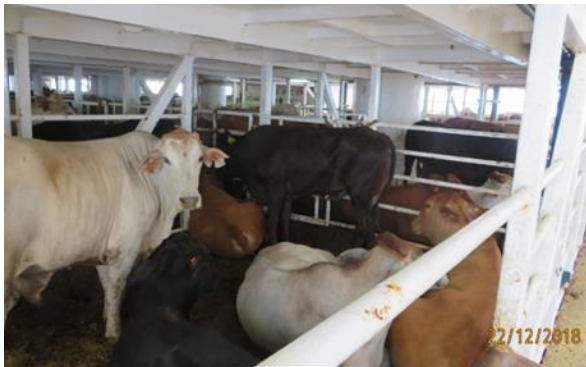
Day 11 Cattle in pen — no issues identified

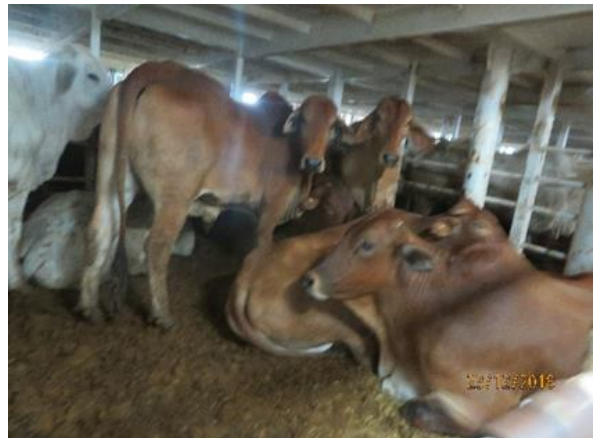
Day 12 Cattle in pen — lower stocking density
